The Chernobyl Accident

**What happened?
What were the root causes?**

Lars Högberg
Former Director General,
Swedish Nuclear Power Inspectorate

April 2016

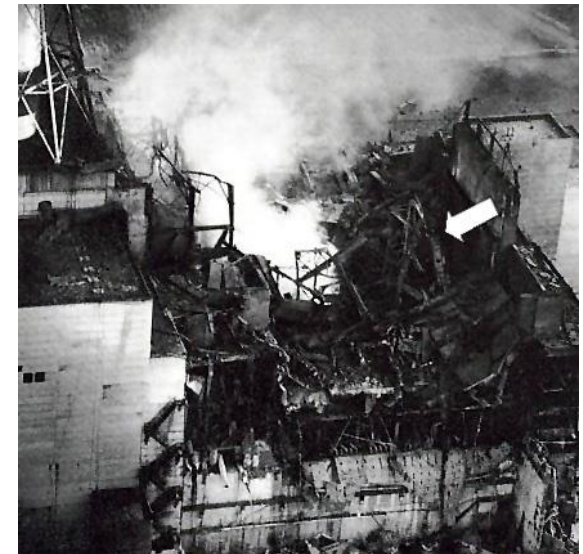
- Escaping steam and gases from ruptured fuel channels overpressurizes the core cavity, lifting and overturning its 1000 ton lid, rupturing all fuel channels, also lifting the control rods out of the core.
- A second explosion occurred, probably the combined effect of control rods (but not fuel and moderator) disappearing and hydrogen. Evaporated fuel and fuel fragments were spewed high up in the air.
- A graphite burn started in the rubble that remained of the core.

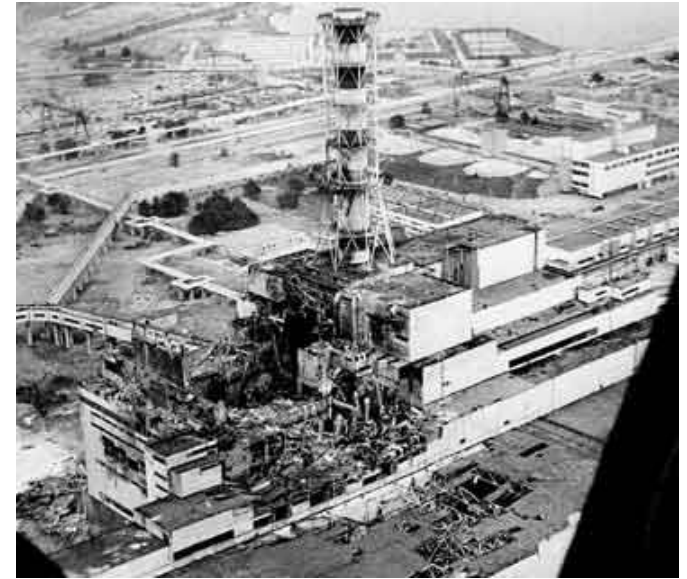
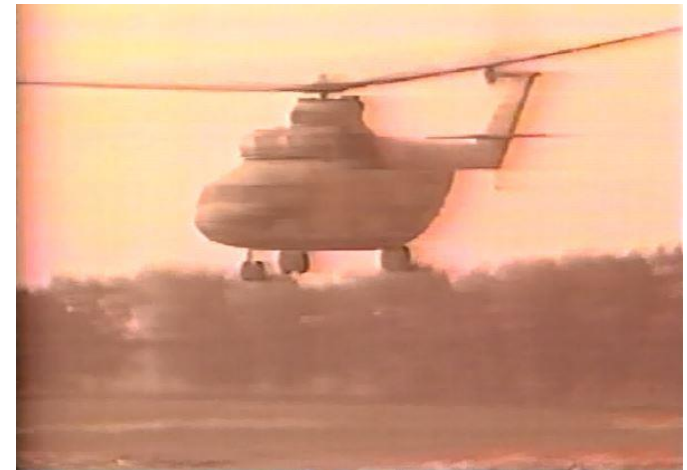
- Hot fuel and graphite fragments initiated fires on the roof of the turbine building and elsewhere.
- The fires were rapidly extinguished by the local fire brigade, but many firemen exposed themselves to lethal radiation doses for lack of protection.
- Attempts were initially made to cool down the damaged core by bombarding it from helicopters with sand and lead but this approach had to be abandoned for fear of overloading remaining building structures.
- After ten days, cooling of the damaged core was achieved by streaming nitrogen from below through tunnels excavated under the reactor building.

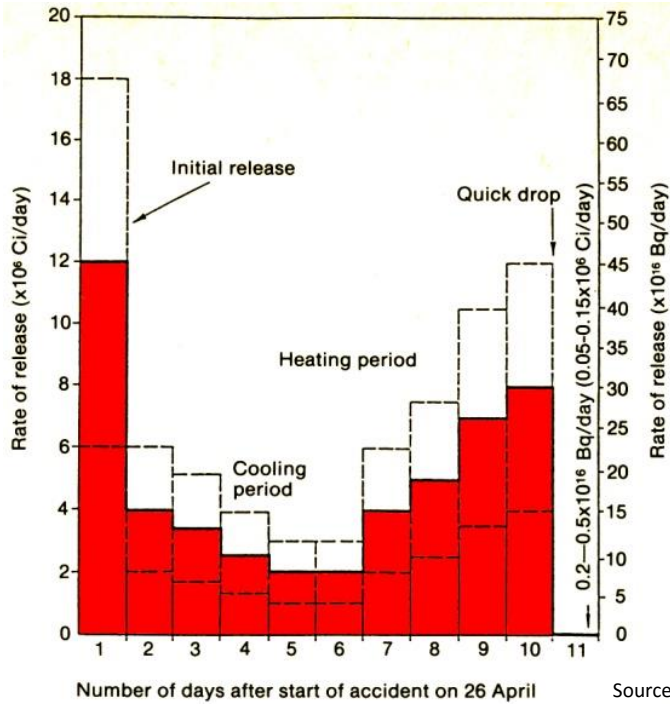
Source: IAEA INSAG-1

Recalling Chernobyl 4 releases – the fallout over Europe
